Test report # PF21079

**Client: Blue Building Solutions Australia
Limited**

**Fire resistance test for the non-loadbearing
framed wall incorporating VENT VB ventilation
cavity battens**

Test method: AS 1530.4:2014

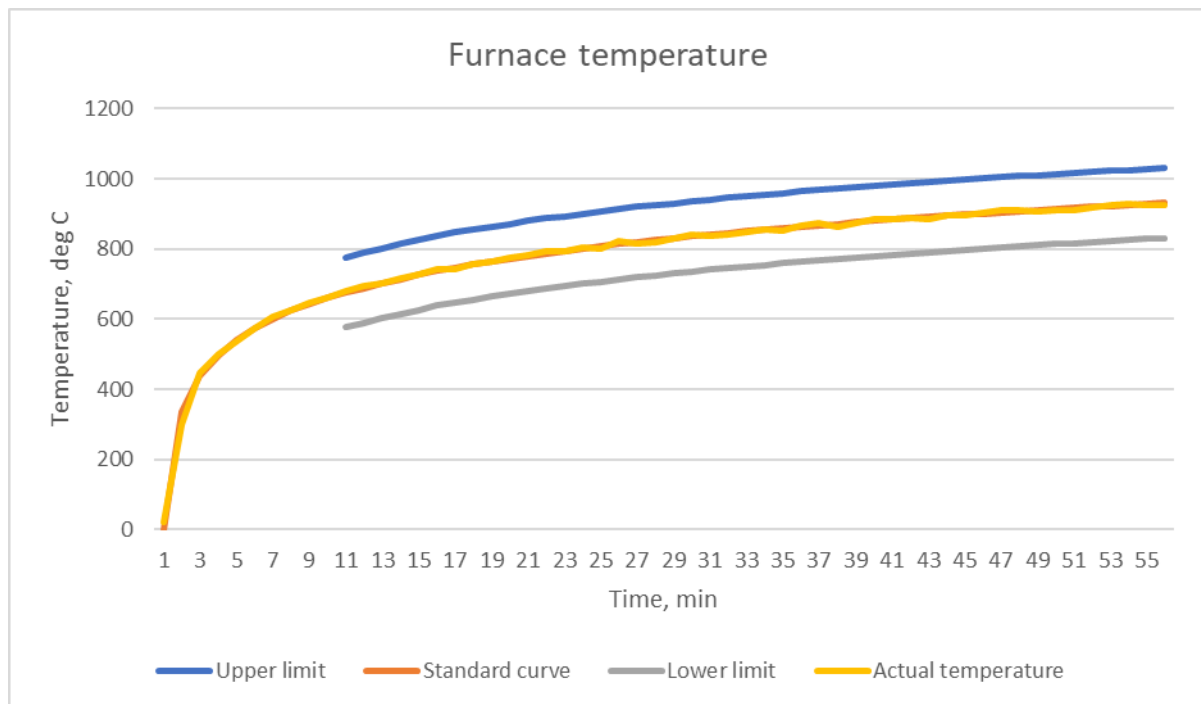
6.1 Furnace Temperature

The furnace was controlled to follow the temperature/time relationship specified in AS 1530.4-2014 as closely as possible.

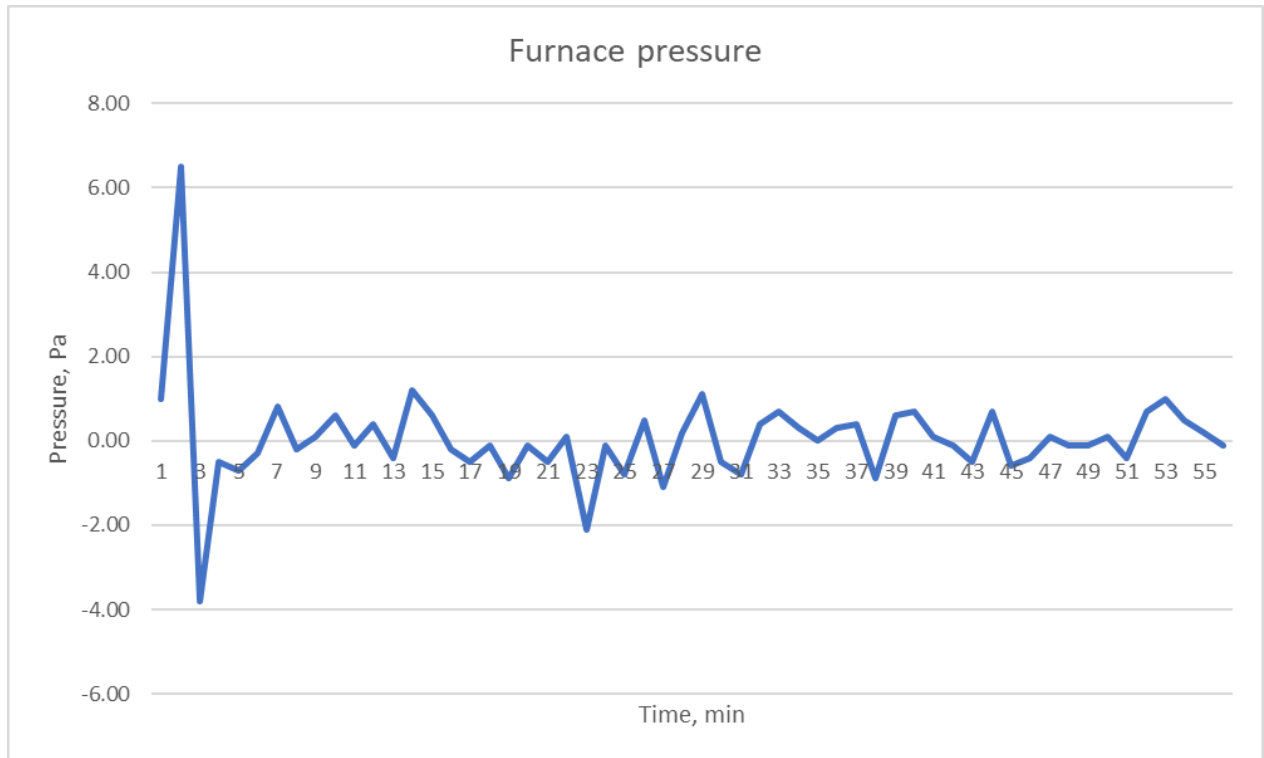
6.3 Pressure Readings

Pressure prods were installed at 500mm above furnace floor and set to 0Pa to control furnace pressure.

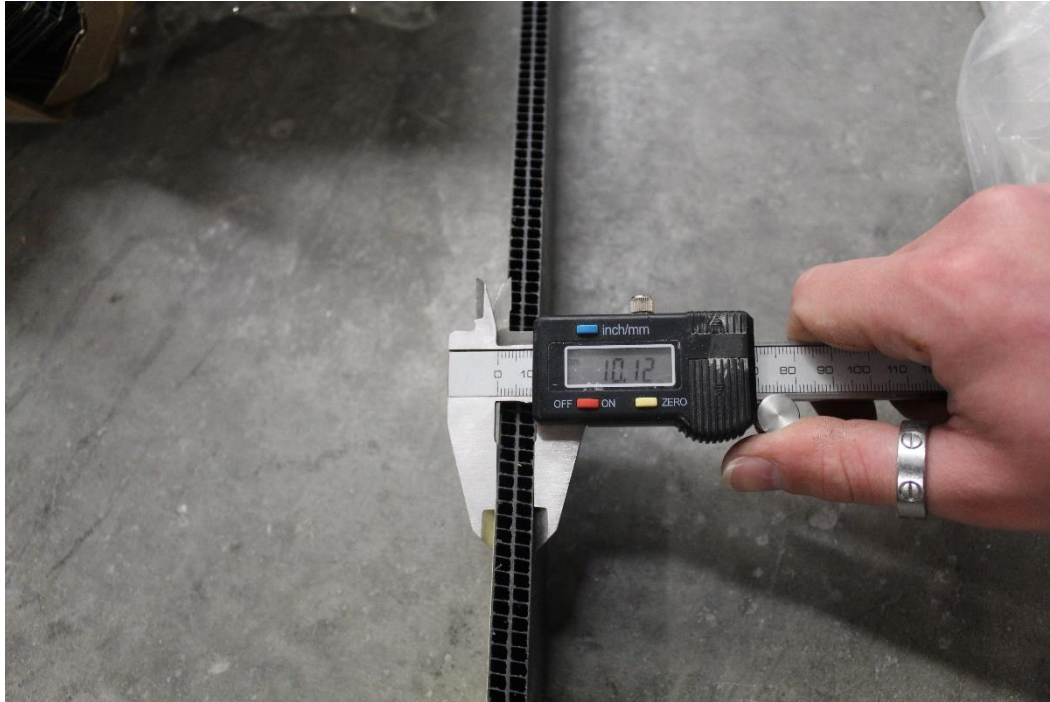
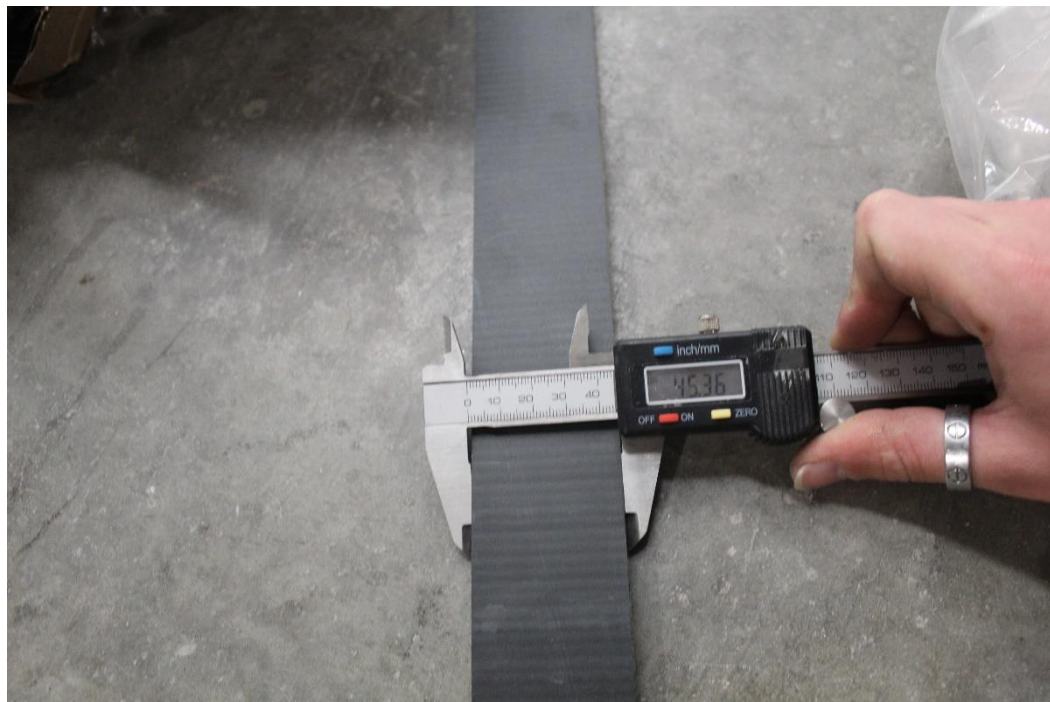
VENT VB10 Ventilated Cavity Batten

The adhesive cover of the Vent battens (1.6) were removed and installed to the wall wrap, on top of the timber frame. The battens were placed along the top and bottom plate, as well as all studs.
